Installation Restoration Program

PHASE I - RECORDS SEARCH

Pittsburgh IAP Pittsburgh, Pennsylvania

U. S. AIR FORCE RESERVE AND
PENNSYLVANIA AIR NATIONAL GUARD
FACILITIES AT
GREATER PITTSBURGH AIRPORT

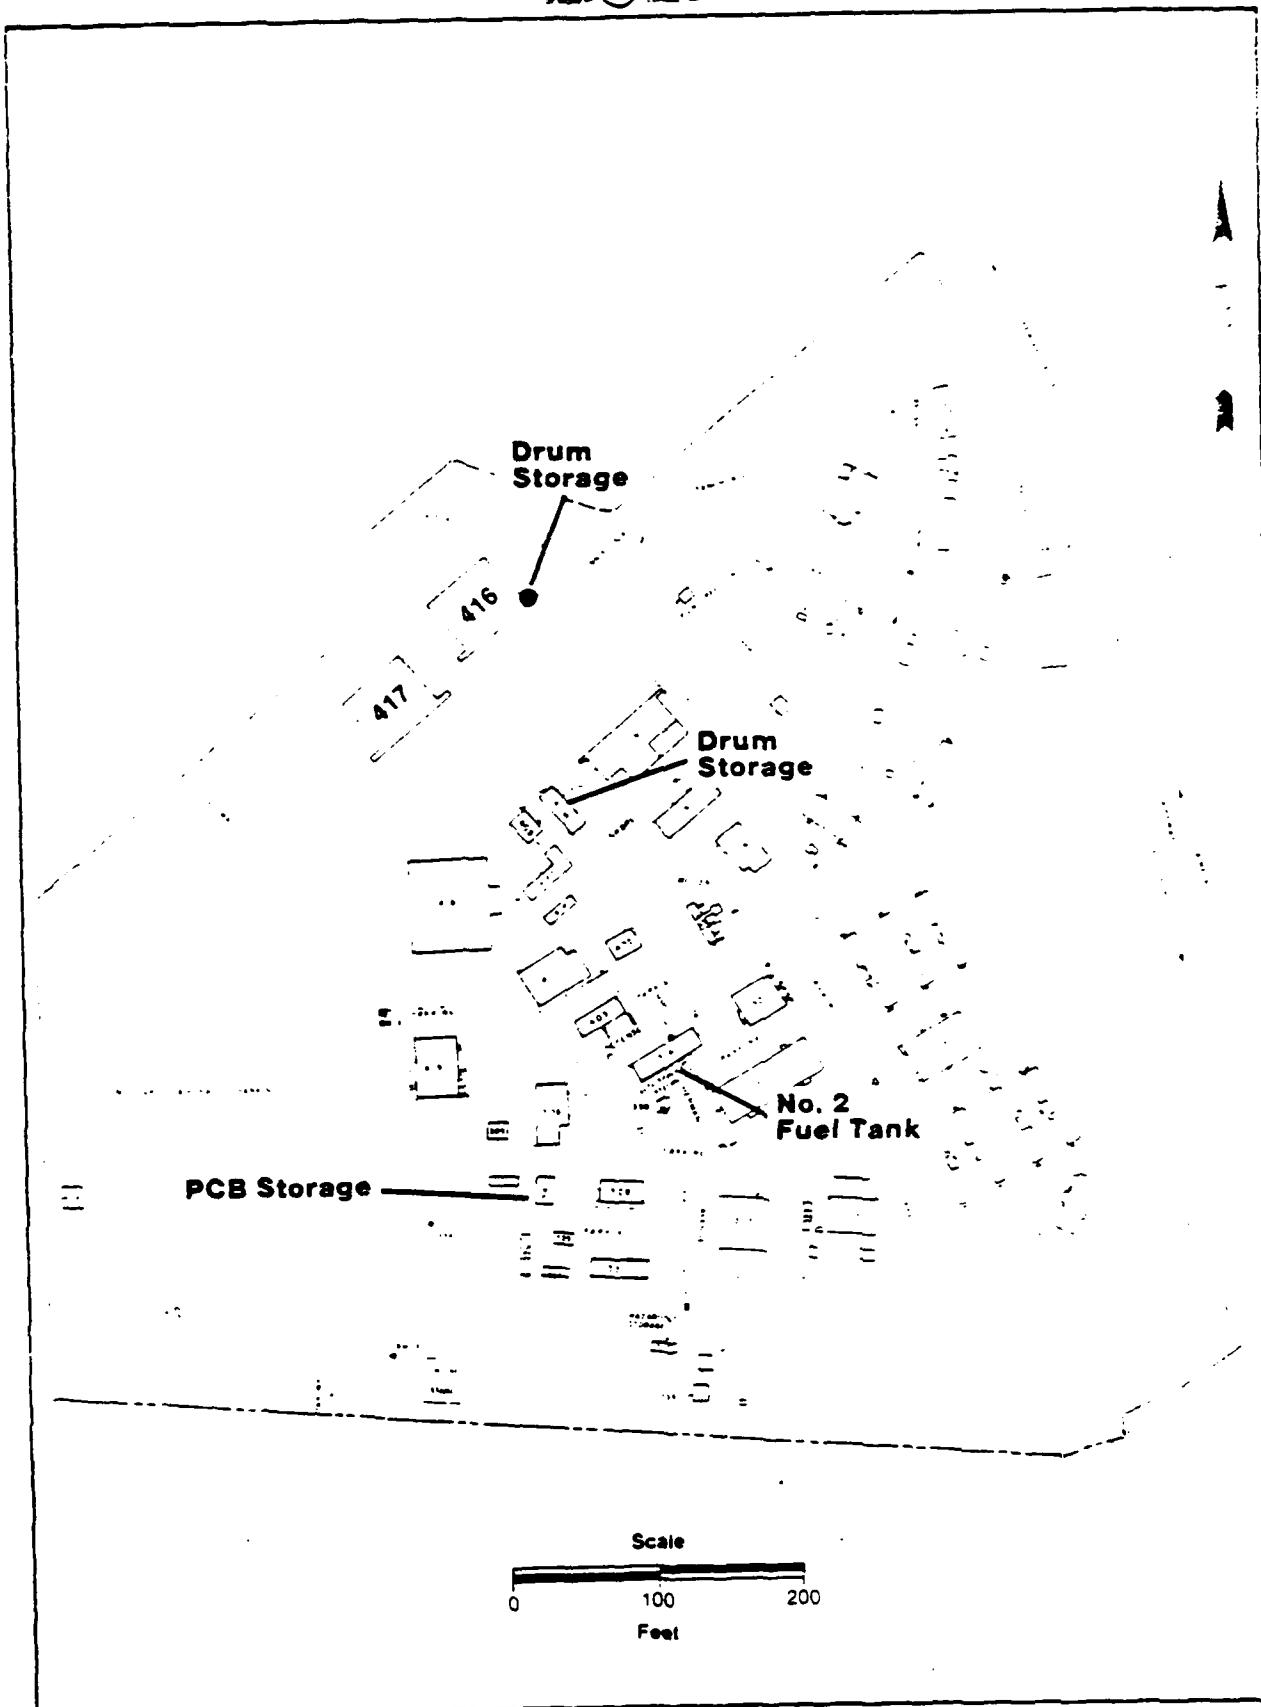
FIGURE ES-1: SITES RATED BY HARM - U.S. Air Force Reserve

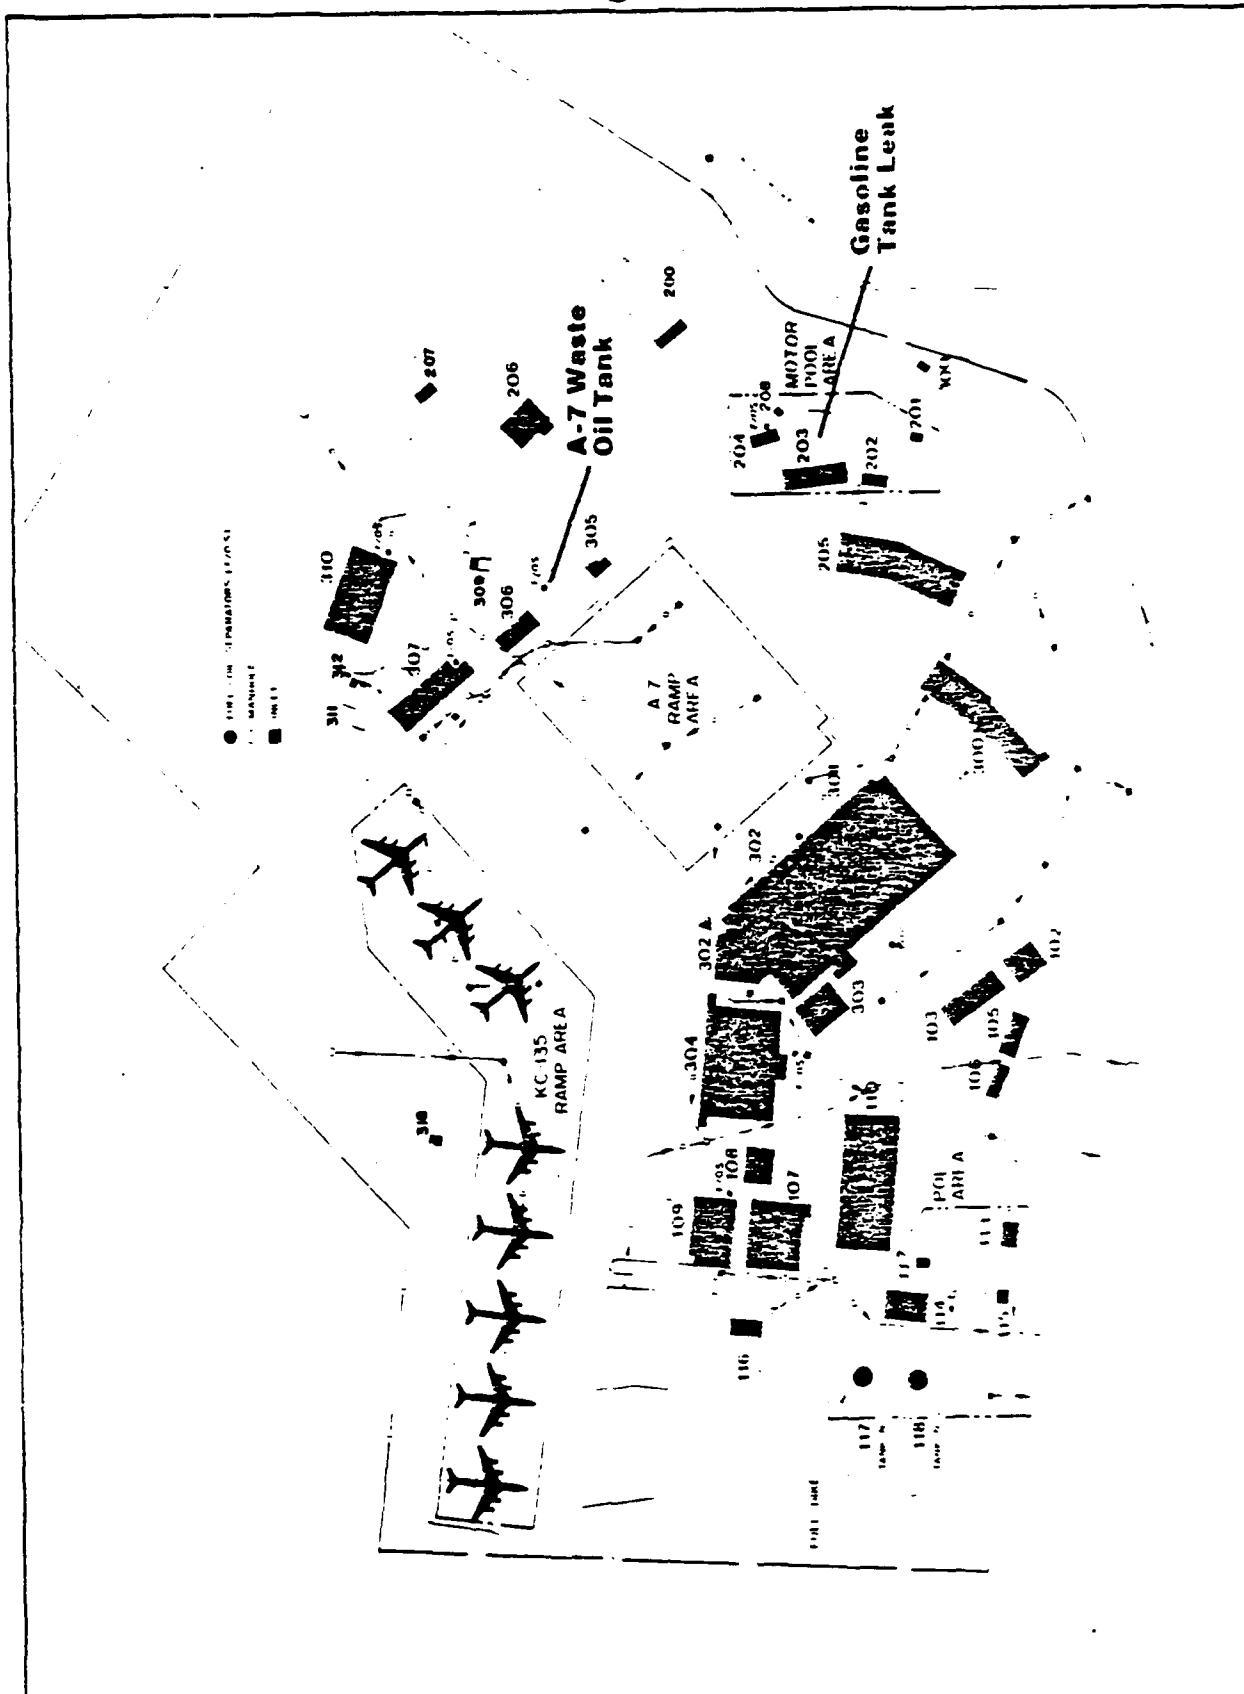
Figure ES-2: SITES RATED BY HARM, PA ANG

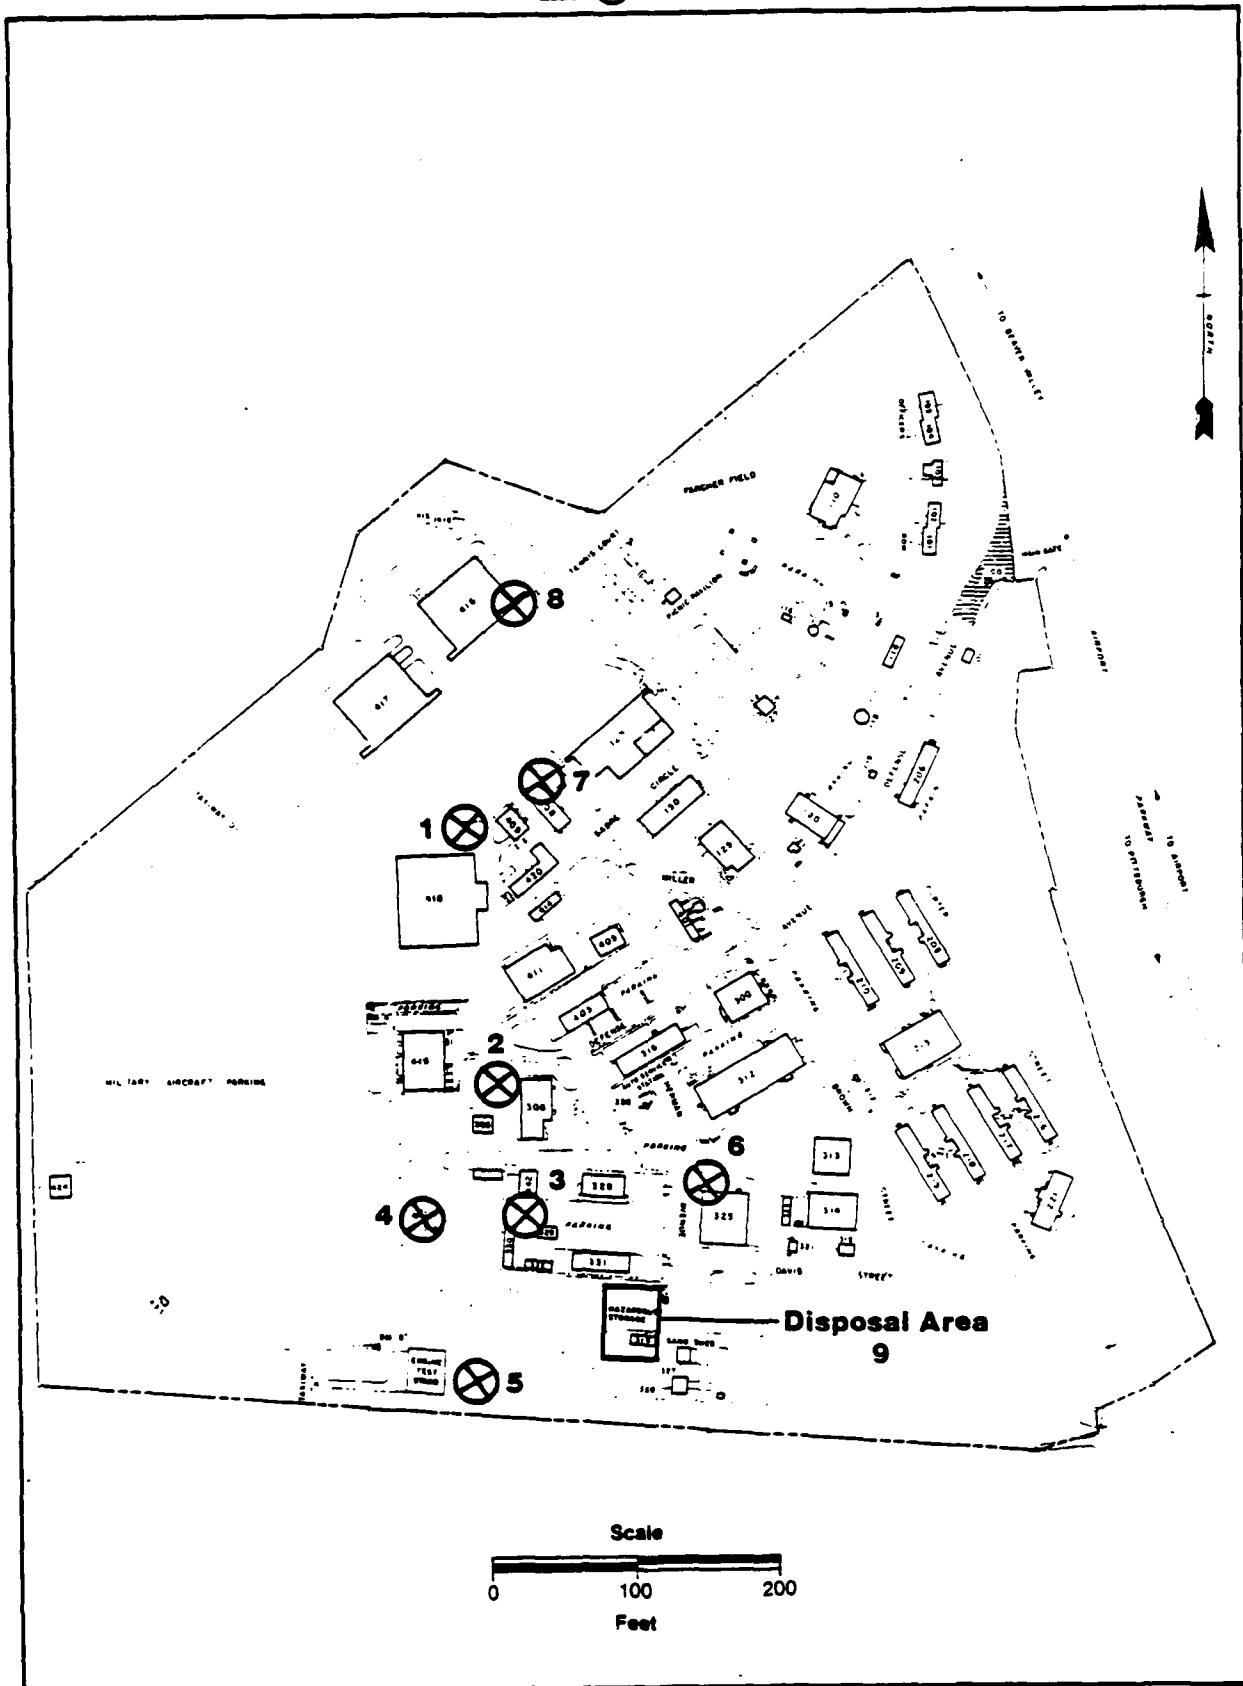
FIGURE 4-1 ON-BASE WASTE STORAGE AND DISPOSAL LOCATION - U.S. AIR FORCE RESERVE

The landfill was located at the AFR base across from the present sand storage area (See Figure 4-1). This was used from early 1950 until early 1960's for normal refuse and used paint cans. In the 60's, it was common practice to burn trash, but there is no indication that any burning of hazardous material occurred. There was one report that radioactive tubes were placed in the fill; this area has been filled in over the years and is now buried by up to 30 feet of cover.

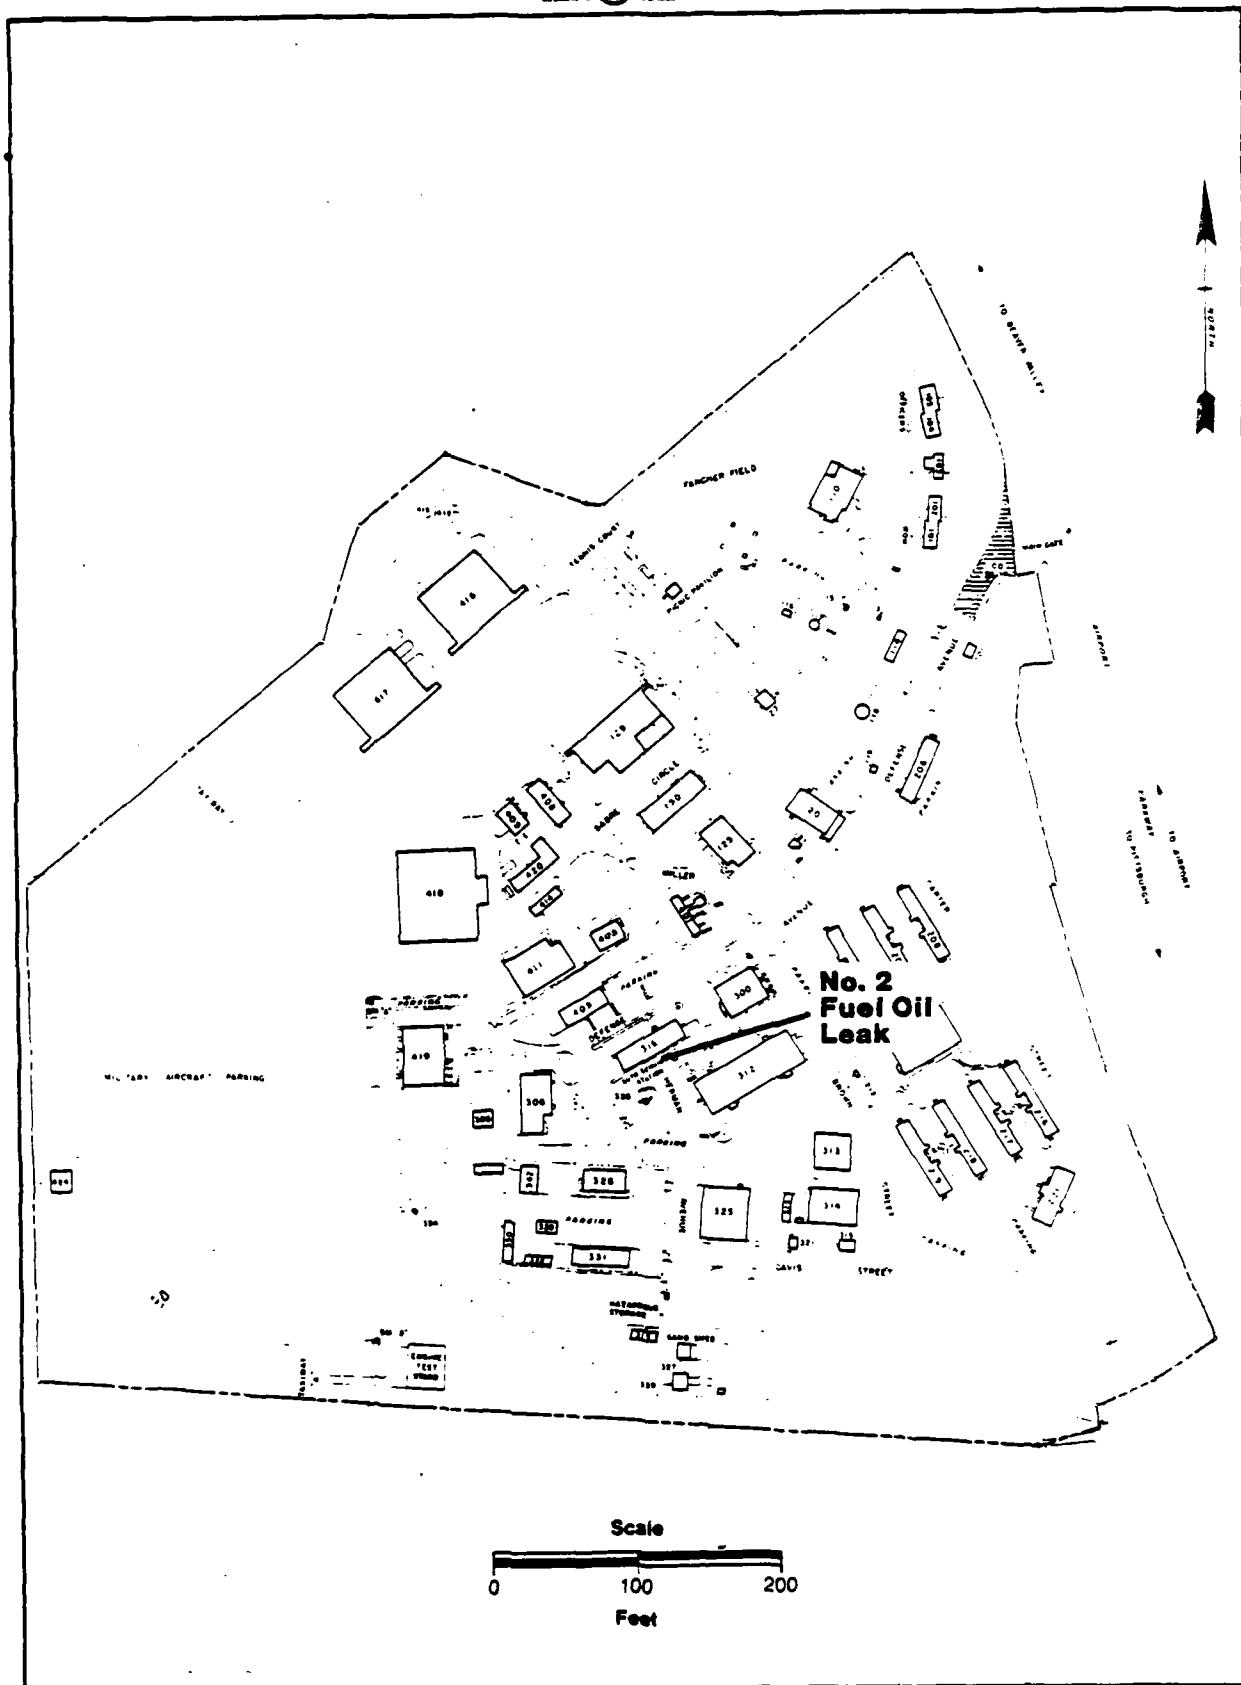
FIGURE 4-2 LOCATION OF TANK LEAKS - 911TH TAG

In 1976 #2 fuel oil was discovered in a storm drain; the source was traced to a 5,000g No. 2 fuel oil tank at Building 316. Upon excavation, the source was found to be in the oil circulation system. The line leading from the pump in the furnace had a 1/4 x 3/8 hole in it. Necessary repairs were performed and the pipe was replaced, but not before fuel oil had travelled through the storm water system and reached the creek. Immediately, booms were put in place to recover any fuel oil. The amount of fuel recovered is unknown. It is assumed that the soil between the location of the leak and the storm sewer has been contaminated and no removal of soil has occurred. Figure 4-2 shows the location of the spill.

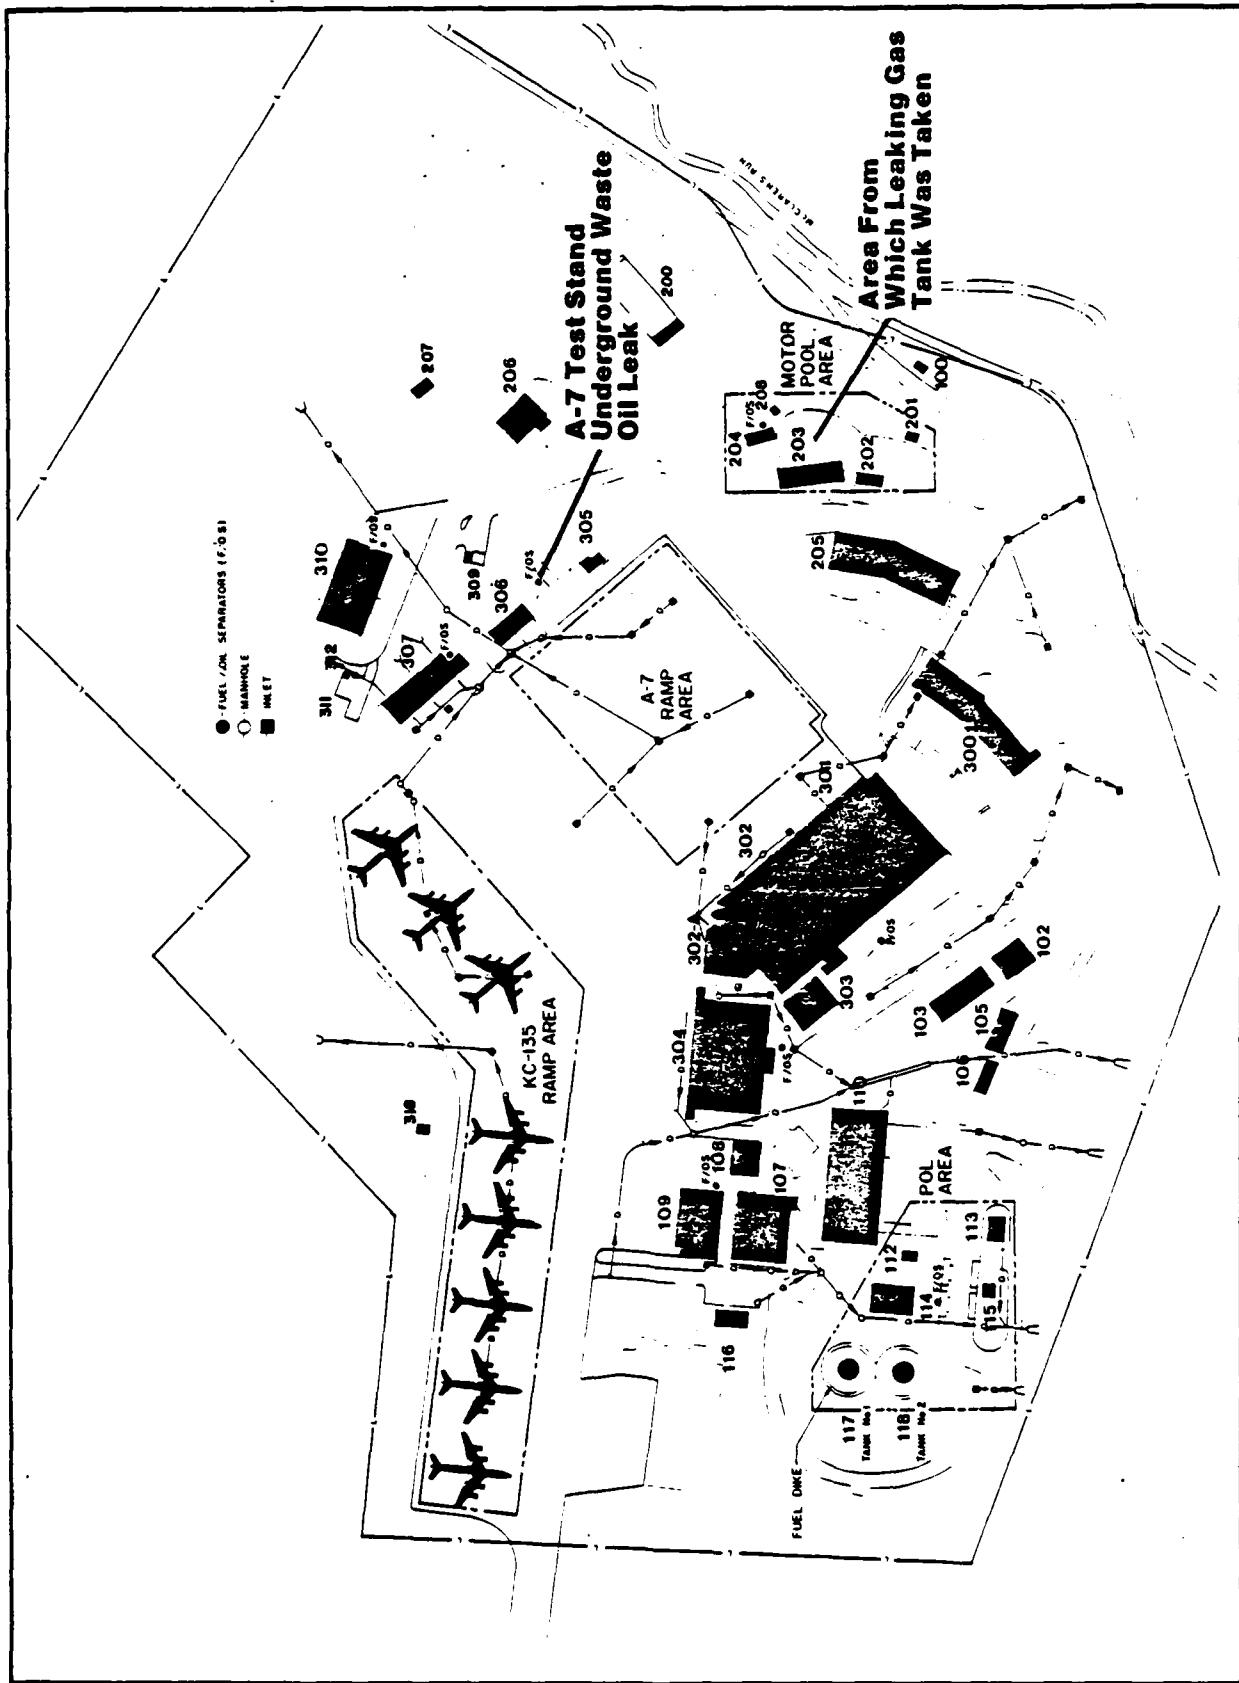
FIGURE 4-3 LOCATION OF TANK LEAKS - PA ANG

The motor pool fuel storage system was changed in 1983 when a single 3,000 gallon tank was replaced by two 5000 gallon tanks and one 3,000 gallon tank. During this change, there was evidence of leakage from the old tank. This is discussed in greater detail in subsection 4.3.5.

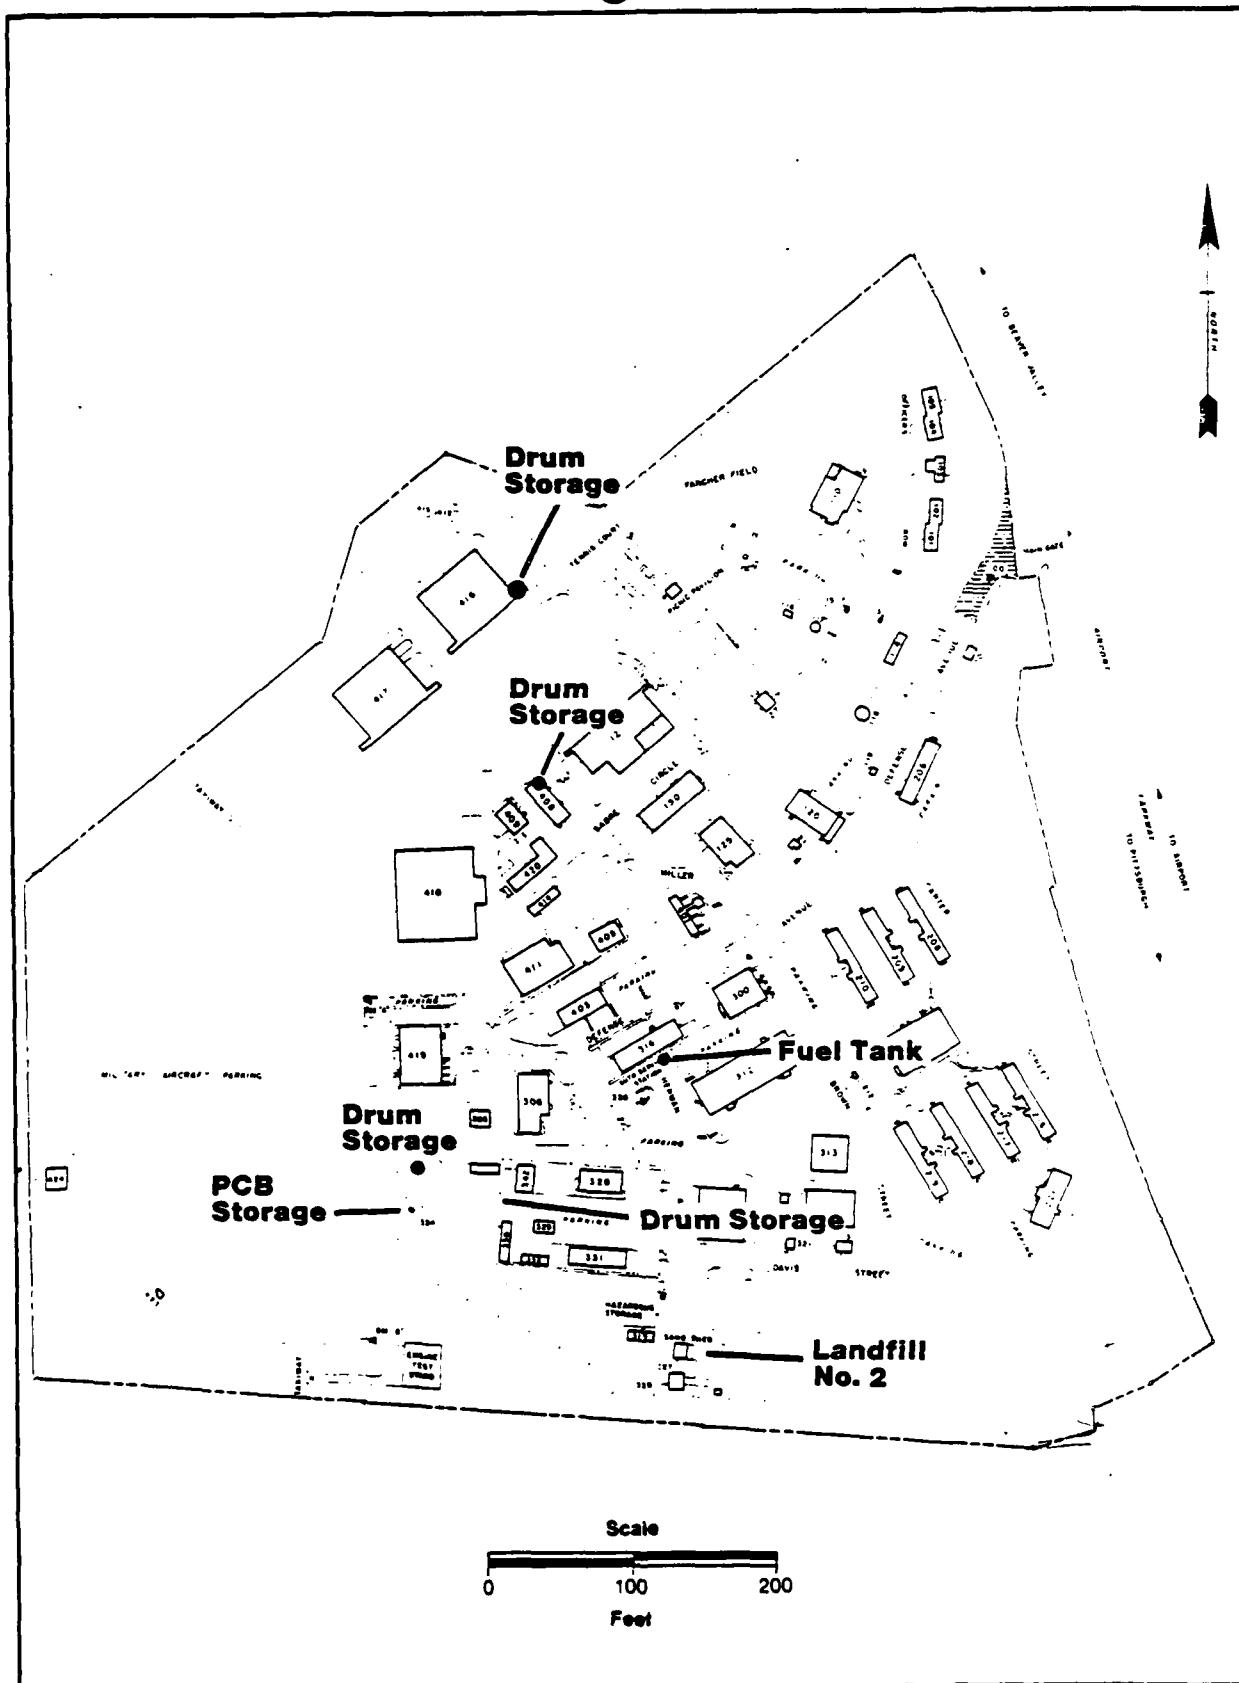
**FIGURE 4-4 SITES OF ENVIRONMENTAL CONCERN-
911TH TAG**

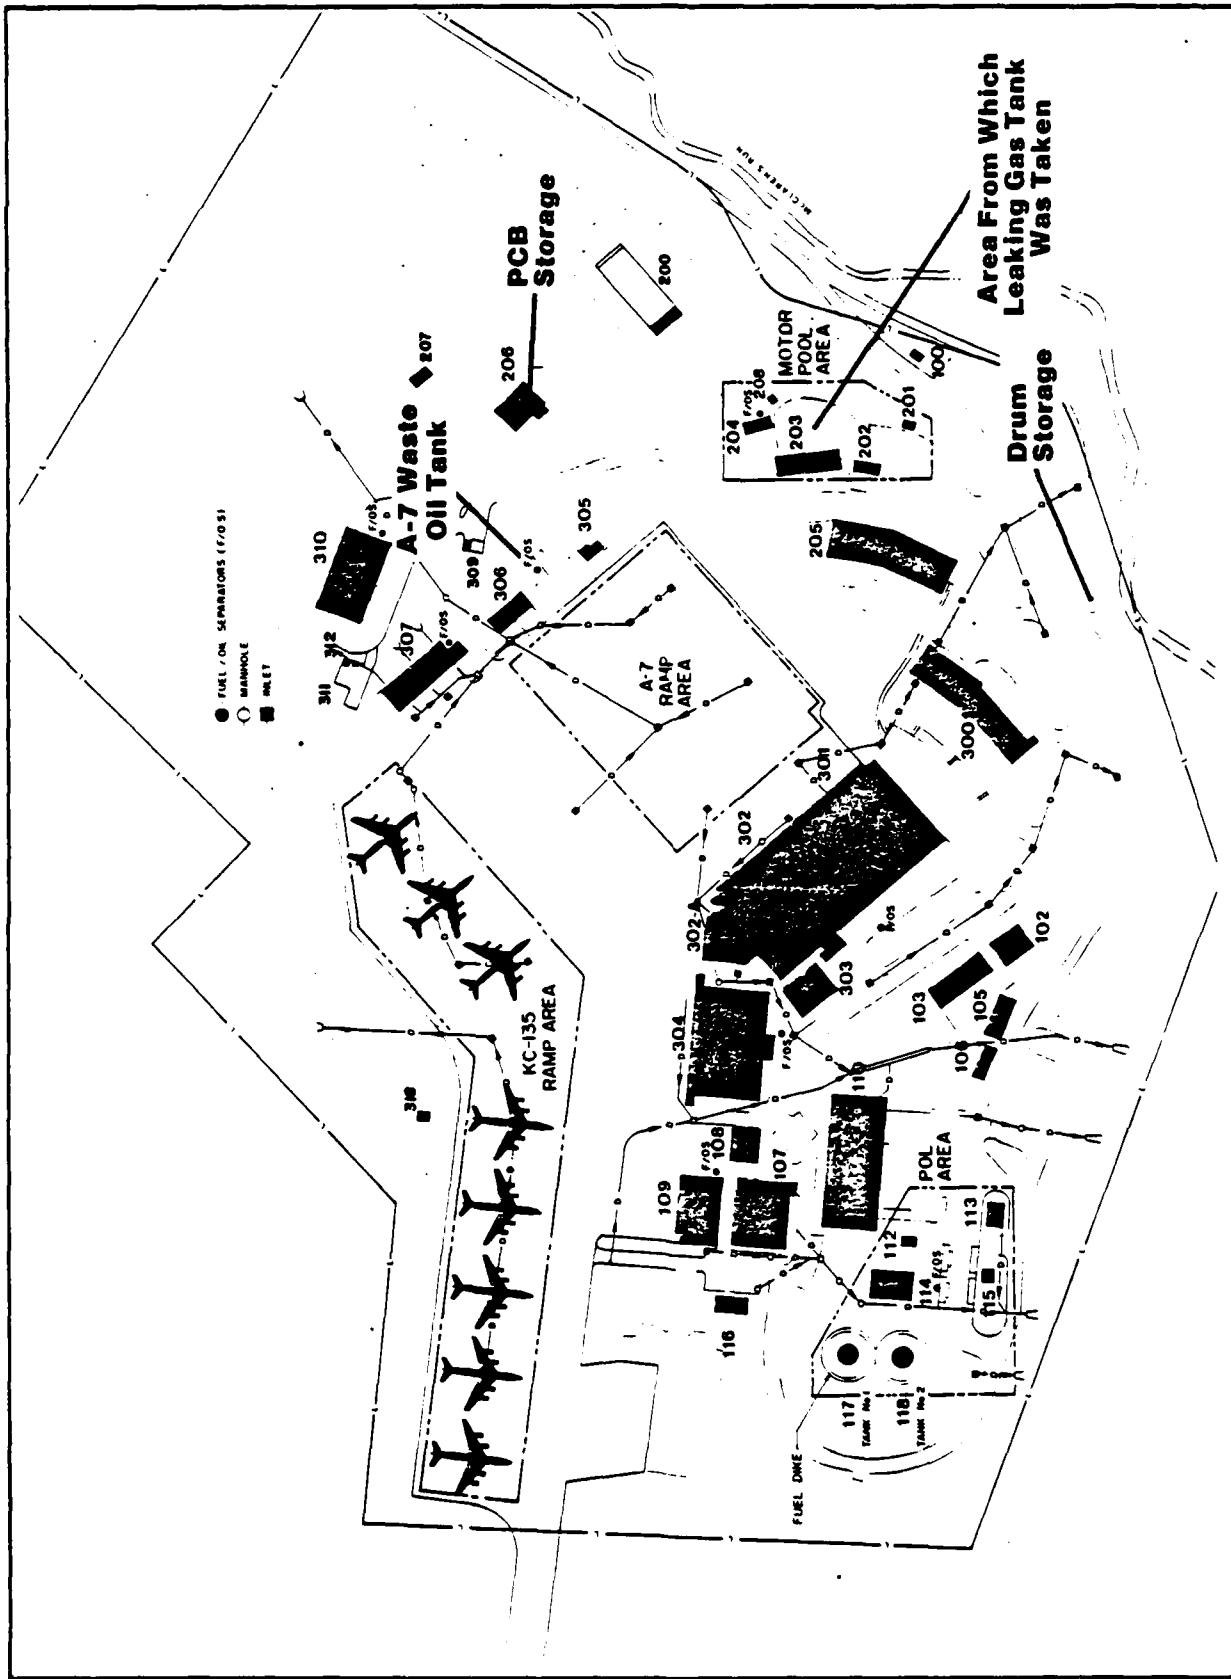
FIGURE 4-5 SITES OF ENVIRONMENTAL CONCERN - PA ANG

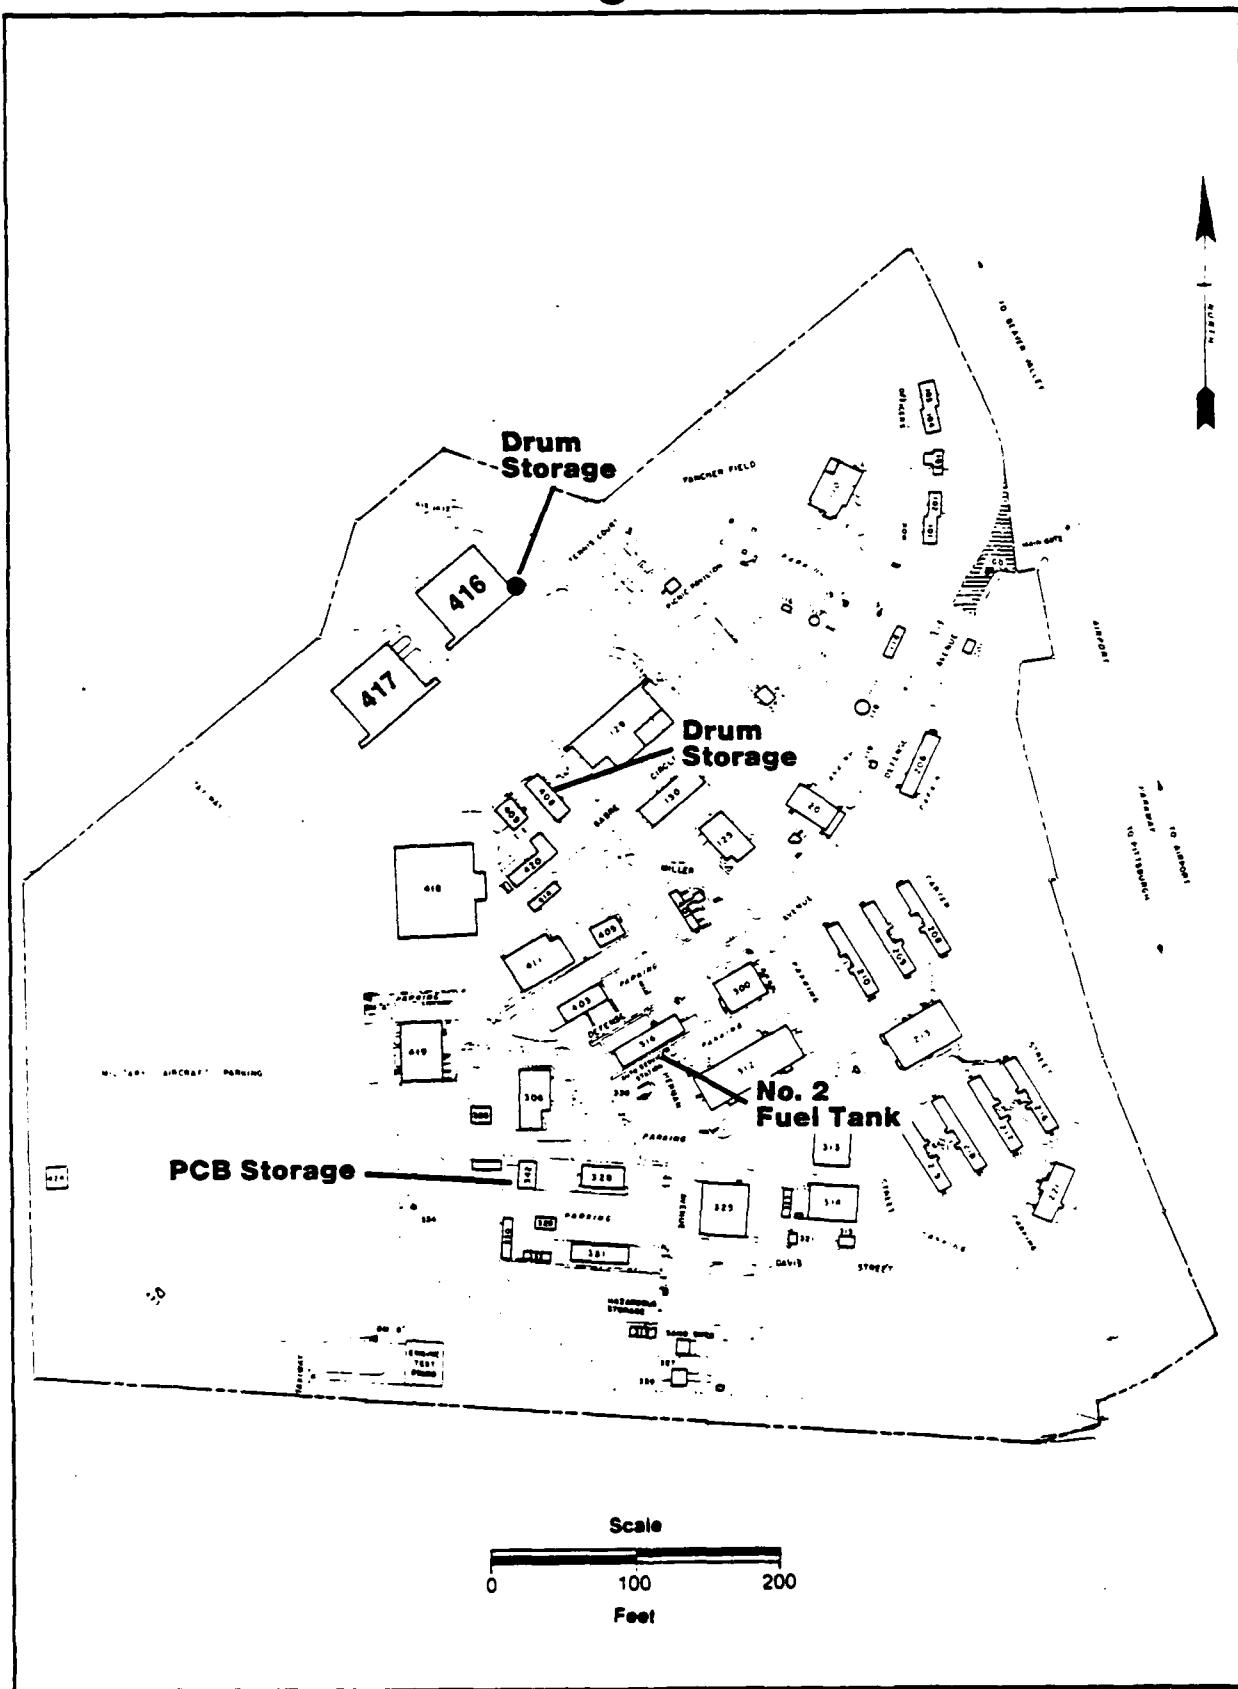
FIGURE 5-1 SITES RATED BY HARM

The leak was detected when oil was found to be entering the storm sewer approximately twenty feet from the tank. Based on this condition it can be assumed that some migration of product has taken place. Soil between the tank and the sewer has not been removed and there have been no analysis of soil or groundwater to determine the extent of migration. It is estimated that most of the 460 gallons of fuel that were reportedly discharged from the tank remains in the ground.

The site received a HARM score of 53.

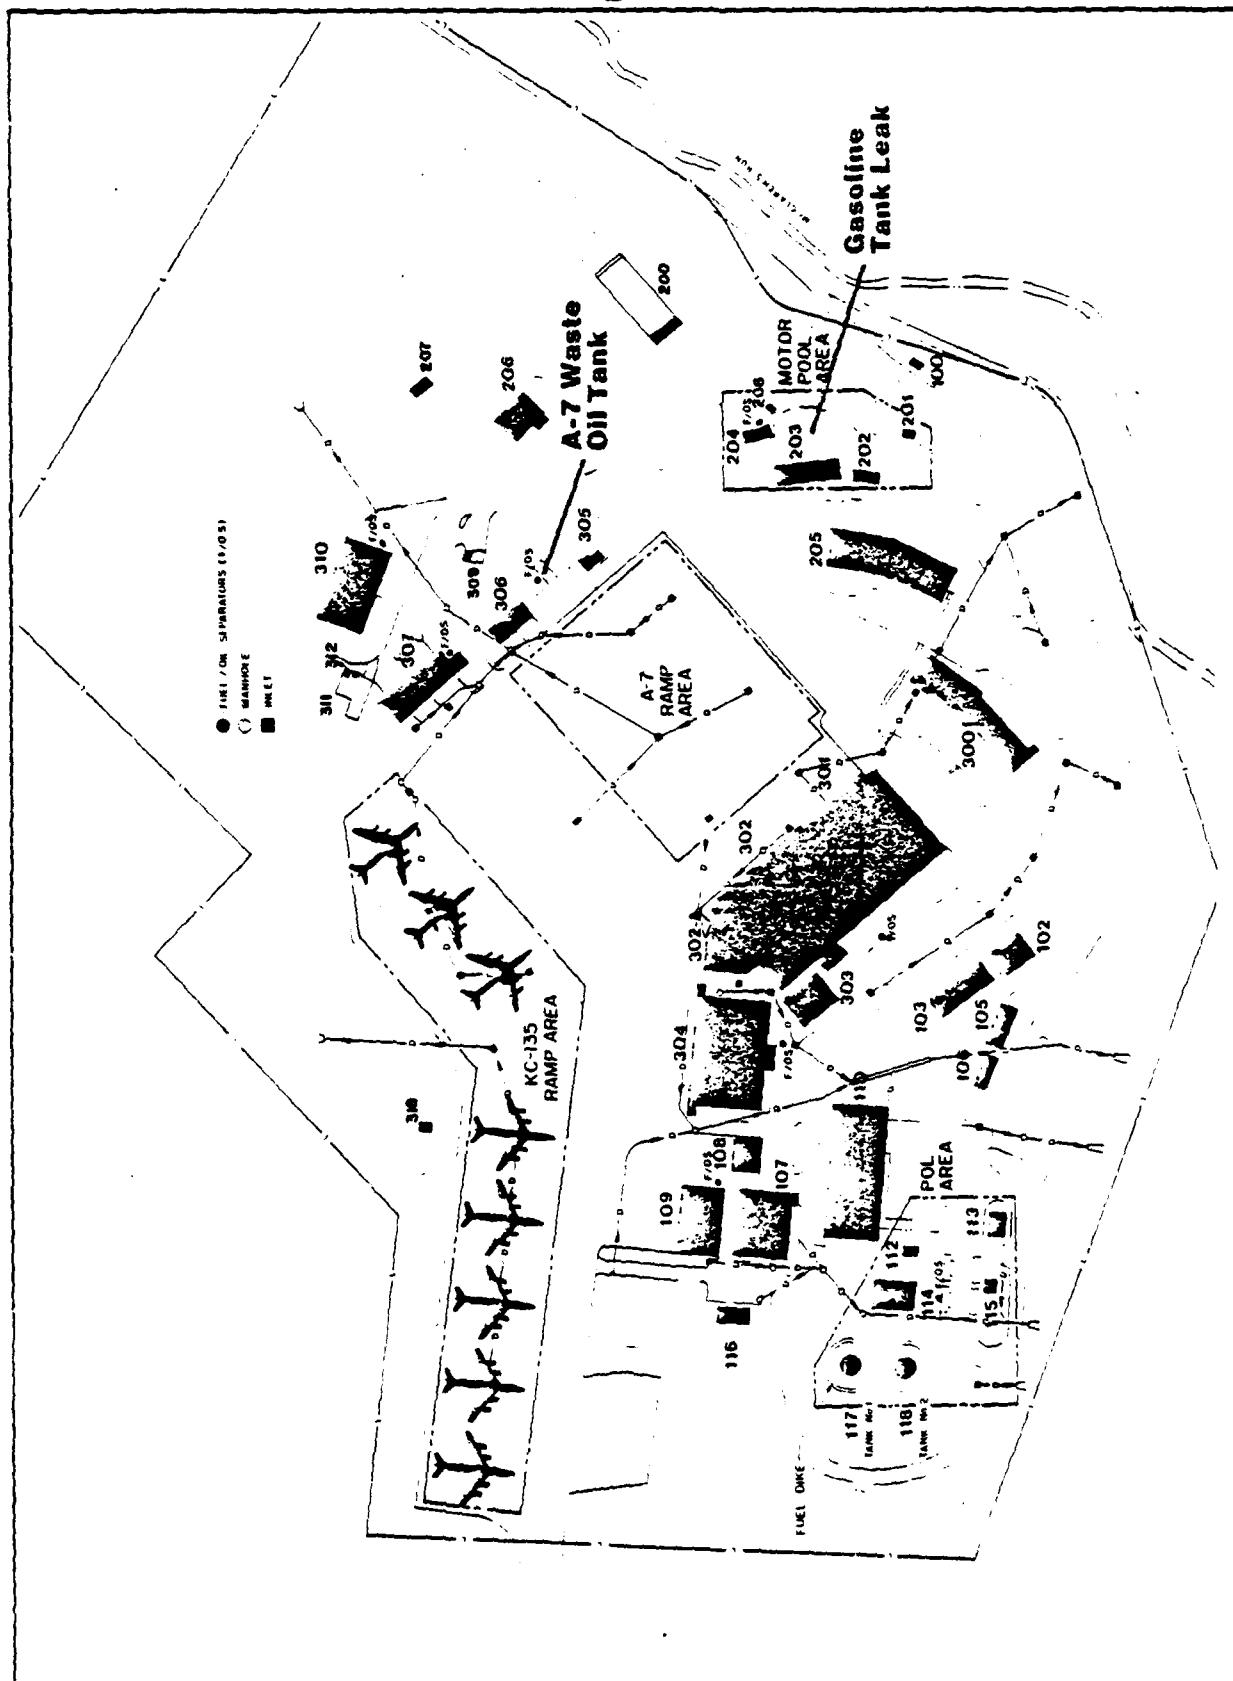
FIGURE 5-2 SITES RATED BY HARM - PA ANG
